EXECUTIVE SUMMARY

This technical report has been commissioned jointly by KiwiRail (KR) and Auckland Transport (AT).

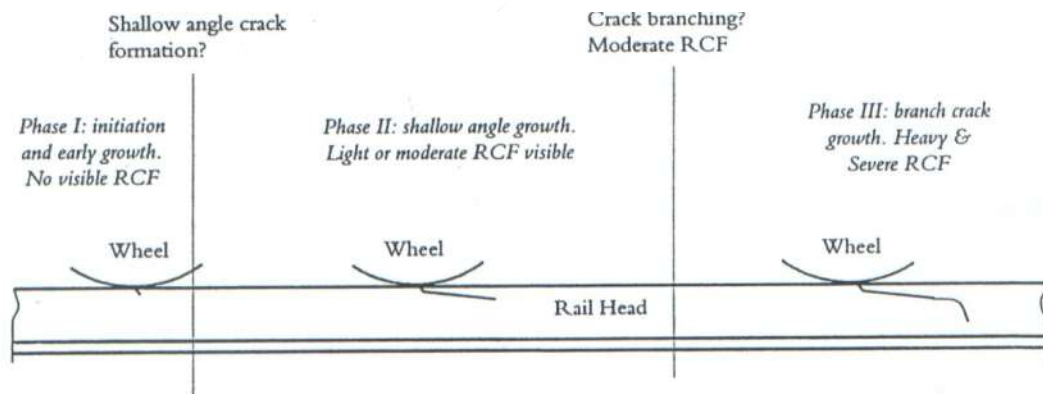
Abbreviated from (AREMA rail grinding)

The growth rate of rail surface (and subsurface) fatigue is influenced by the level of contact stress between the wheel and the rail. Micro-cracks develop at the most stressed portion of the rail surface. In their early phase the microscopic cracks grow quickly in a somewhat vertical direction (not visible) to a shallow depth in the rail surface. The cracks then enter a phase of shallow angle growth (planar growth) until they reach a branching phase. At this phase the rate of growth in the vertical direction accelerates. The preventive grinding strategy is designed to cycle the rail grinder at frequent intervals to remove a thin surface layer of metal from the rail to prevent the micro-cracks entering the rapid phase of growth.
