# Asset Condition Inspection Update Q3 2019/20

# Purpose

This report is provided on a quarterly basis and provides an overview of the condition of Auckland Transport's structural assets and an update on the progress and outcomes of inspections undertaken.

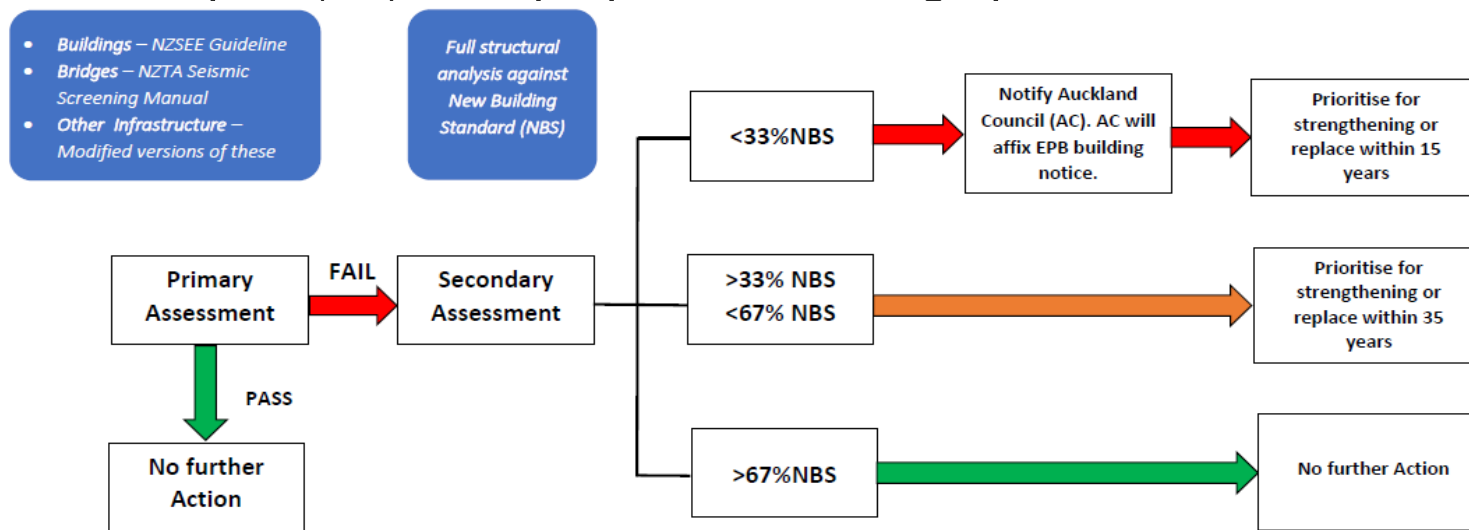
- The Building (Earthquake-prone Buildings) Amendment Act 2016 introduced major changes to the way earthquake-prone buildings are identified and managed under the Building Act (2004).
- Auckland is classified as a Low Seismic Risk zone where building owners are required to complete seismic assessments within 15 years and take action to remediate their buildings to achieve a minimum 34%NBS standard within 35 years.
- AT is drafting a policy for the management of risks associated with seismic events for all transport assets, and buildings owned, leased, occupied or managed by Auckland Transport (AT). The proposed two stage process is summarized below:
